**DOT/FAA/AR-02/80**

# **Impact Damage Characterization and Damage Tolerance of Composite Sandwich Airframe Structures – Phase II**

October 2002

Final Report

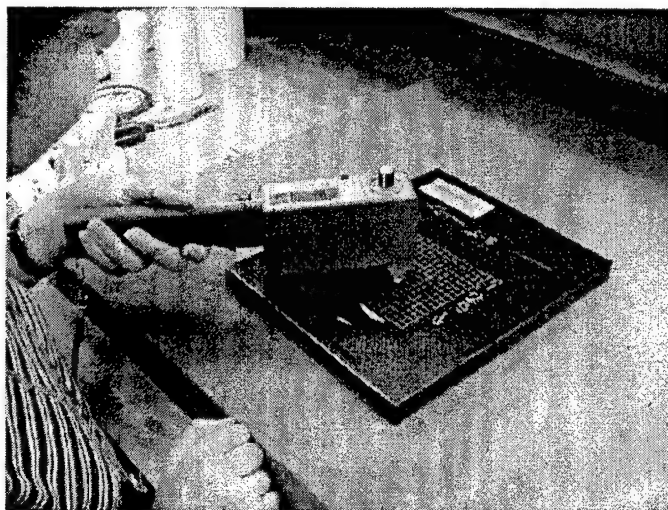
FIGURE 5. MITSUI WOODPECKER AUTOMATED TAP TESTER

In mechanical tap testing, the impact (tap) force is measured using an accelerometer that is mounted behind the impactor. The magnitude of the force and impact duration will depend on the constitutive properties of the sandwich components, impact energy, and impactor properties. The duration of impact (period) has been reported to be rather insensitive to the magnitude of the peak impact force for sandwich panels [5], which ensures repeatability. However, the impact duration will be significantly altered when the local stiffness of the sandwich structure is reduced due to the presence of damage. This change in impact duration is used to identify damage in sandwich structures. In the present investigation, the Mitsui Woodpecker Automated Tap Tester [6] (shown in figure 5) was used to identify the impact damage in sandwich panels.

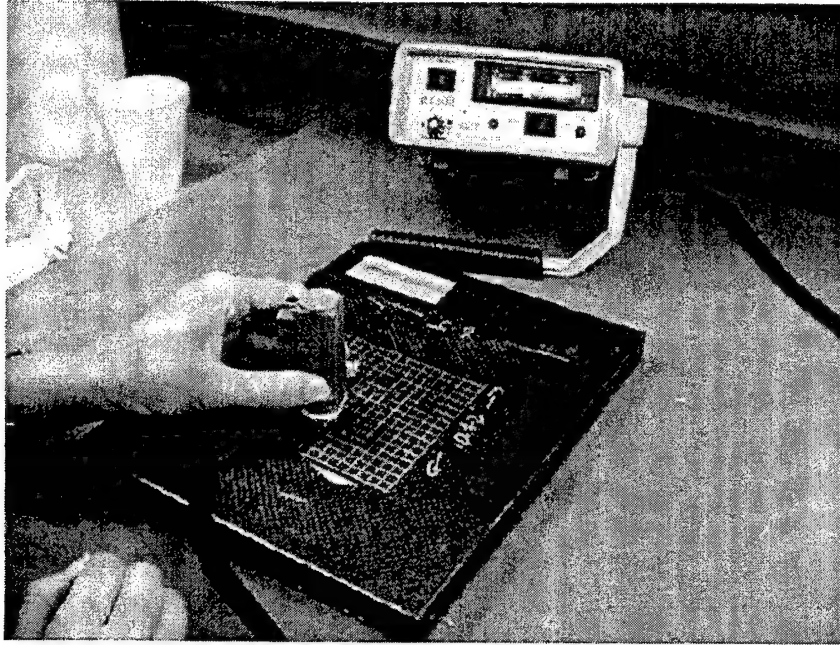
FIGURE 7. V-95 BOND TESTER USED FOR MECHANICAL IMPEDANCE ANALYSIS

In the MIA method [7], the stiffness of the structure in contact with a probe tip is measured. The mechanical impedance (stiffness) of the structure is a function of the constitutive properties of the sandwich components. The MIA method has been frequently used for identifying flaws in adhesive bonds. The presence of facesheet or core damage will reduce the mechanical impedance of the sandwich structure, and can result in a phase or amplitude change to the displayed signal, depending on the frequency of the probe. The probe consists of two piezoelectric crystals with the driver positioned behind the receiver within the same holder. The driver converts electrical energy into sonic vibrations and the receiver, in direct contact with the test surface, converts the modified vibrations into electrical signals for processing by the instrument. The V-95 Low-frequency bond tester used in the present study is illustrated in figure 7.
